CASE STUDY - Traditional Style Staircase – Alton, Hants

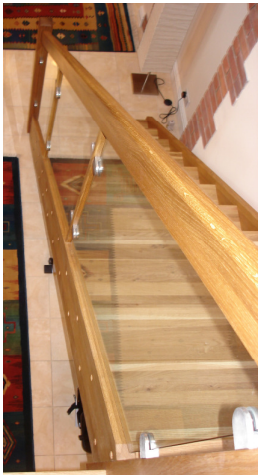
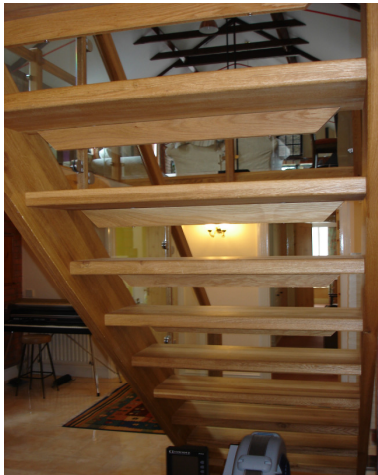
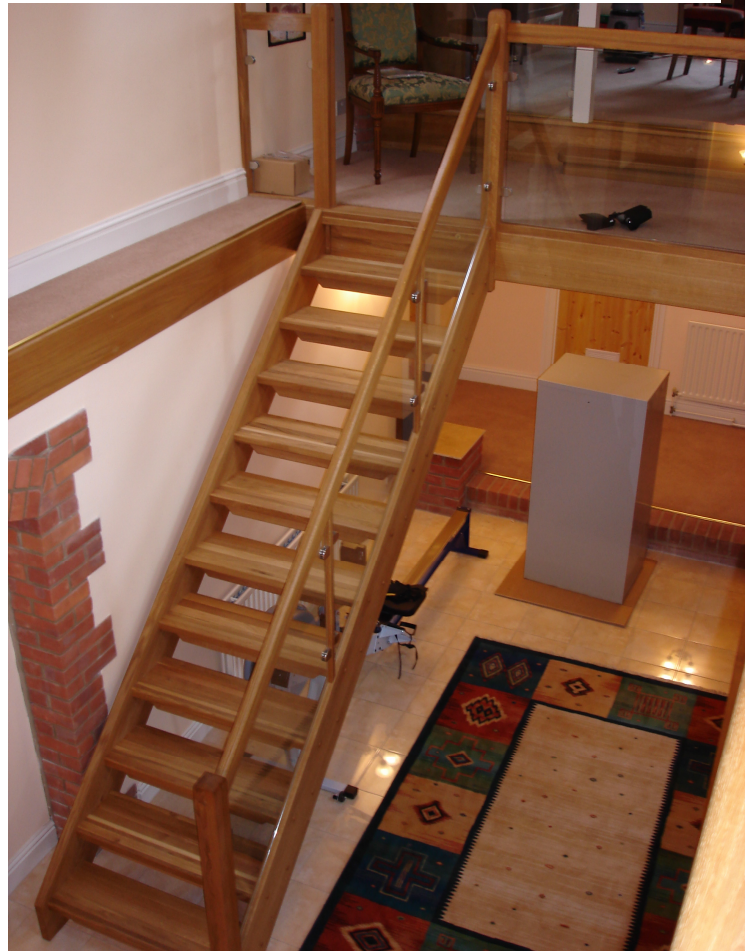
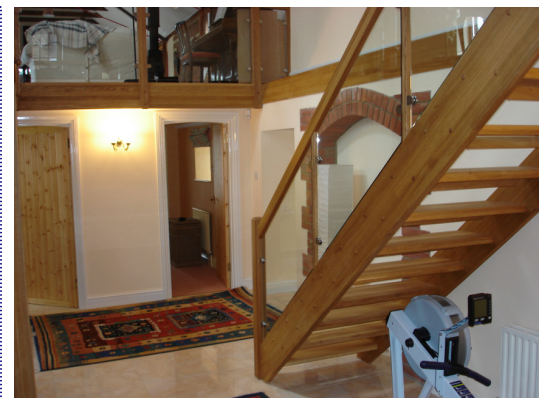
This customer was looking to replace their staircase after suffering flood damage to the lower part of the house. Replacing everything gave them the opportunity to create a more impressive look to the room. The large void above the living room meant that a large galleried area existed; glass infill panels in the balustrade allowed a light and airy feeling to be incorporated into a safety feature around the opening. The stair itself, constructed of Varnished Oak, was a fitting centre piece to the new design of the property.

FLOOR TO FLOOR HEIGHT	-	2600mm
RISERS	-	14 @ 185.7mm
GOING	-	230.8mm
CLEAR TREAD WIDTH	-	900mm
TREADS	-	42mm Solid Oak
STRINGERS	-	42mm Solid Oak
NEWEL POSTS	-	80 x 80mm Oak (no. 1 in range)
HANDRAIL	-	no. 1 in range – Solid Oak
BALUSTRADE INFILL	-	8mm toughened glass panels
LANDING BALUSTRADE	-	9000mm
